## MEMORIAL OF PERPETUAL TEARS

### WALKABILITY REPORT

July 10, 2019

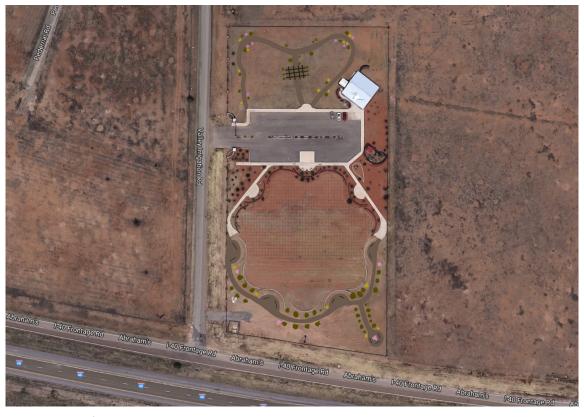
Aerial view of the memorial, showing the proposed, completed walking path.

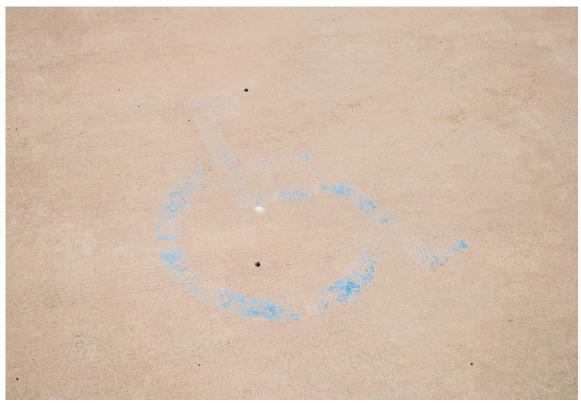
Painted disabled parking markings.

- Dedicated disabled parking is signed and marked, although faded.
- There is no description of the decorative tree inside the visitor's center.
- A digital marquee has been erected in town, and Moriarty has agreed to display advertisements for the memorial.

Once inside the park, several areas for signage improvement were noted. Parking was somewhat ambiguous; aside from designated disabled spaces at the trailhead and visitor's center, there were no posted signs or painted markings for parking. While not appreciable, it could cause confusion among some visitors. Additionally, the painted markings for handicap parking were noticeably faded and could benefit from refreshing.

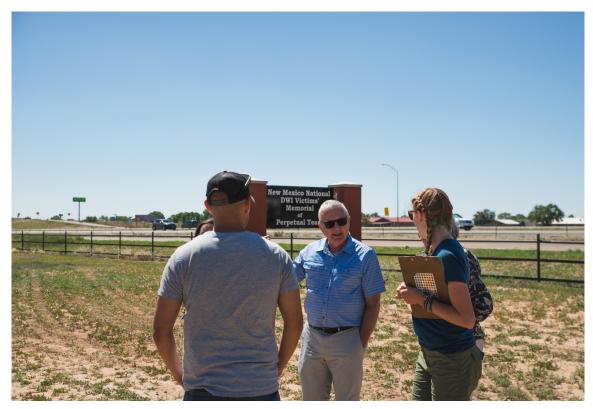
Large, descriptive signs along I-40 indicate which off-ramp to exit on, and signage posted on Howard Cavasas Boulevard, Abrahams Road West, and North Broadway direct drivers to the park entrance. There are also two large signs on-site, one at the main entrance, another at the southern edge of the grounds, that effectively notify passers-by as to the name of the memorial. Additionally, the town of Moriarty has recently erected a digital marquee at the intersection of Central and NM-41, and Perpetual Tears Inc. has established an agreement with the town to display advertisements, which may further increase visitation to the park.

*Signage and visibility off Interstate-40 is excellent.*

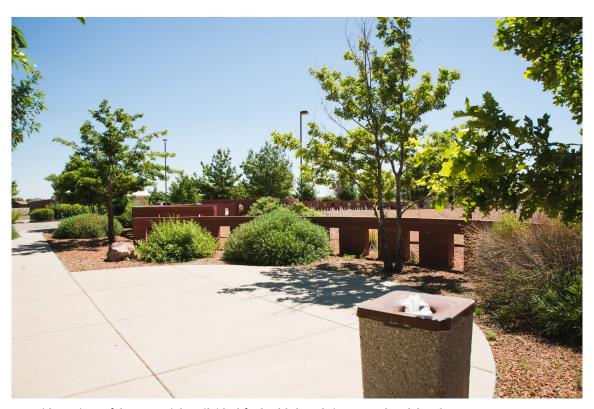
Wide sections of the Memorial Trail, ideal for health-based signage and park benches.

There are several points along the existing trail where the pavement opens up into a widening. Some of these spaces are currently vacant, but represent ideal opportunities for the placement of benches or tables for visitors to rest and reflect on their experience at the memorial. These widening's could also function as dedicated "health stations" with the installation of health-themed signage, promoting various types of physical activity and their associated health benefits.

- I. INSTALL A TRAILHEAD KIOSK WITH DESCRIPTIVE INFORMATION ABOUT THE PATH.
- II. POST RESTROOM AND WATER FOUNTAIN SIGNAGE FOR THE VISITOR'S CENTER.
- III. POST TYPICAL HOURS OF OPERATION.
- IV. INSTALL DISTANCE MARKERS AND HEALTH-BASED SIGNAGE
  AT KEY POINTS ALONG THE TRAIL.

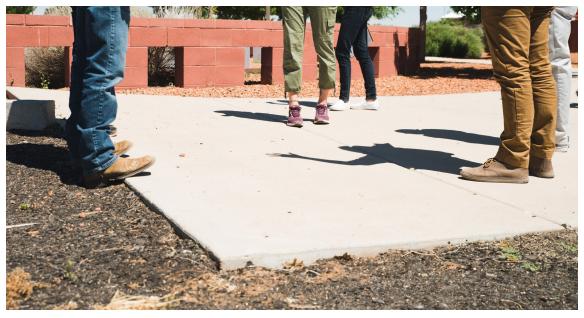
Evaluators assessing the surface of the existing walking path.

- The existing trail is smooth and level.
- The unpaved section of trail is clearly delineated and ties in well with the existing trail.
- Benches are located on both sides of the existing walking trail.
- Shade for benches is provided by trees.
- Parking lot pavement contains linear cracks.
- Bushes and other vegetation partially block access to the trail.
- Weeds are present throughout site, indicating landscaping may be required.
- The unpaved section of trail consists of loose sand, recycled material, and organic vegetation.
- Restrooms are located inside the visitor's center.
- Water fountain is located inside the visitor's center.
- Streetlamp style lights exist throughout the grounds.

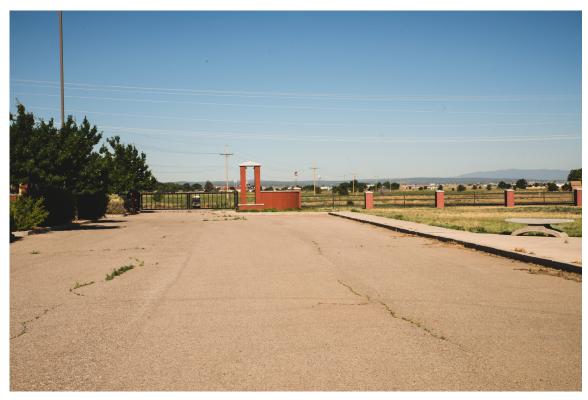
Linear cracking evident on parking surface.

The walking trail is currently partially paved, with approximately half of the trail existing as a combination of loose dirt and pulverized, recycled roofing shingles. The paved section of trail is level with some linear cracking noted, particularly along the sidewalk at the north end of the parking lot. While cracks exist, there was no upheaval and the surface was relatively smooth and level, indicating minor patchwork may be necessary in the future.

- I. IMPROVE SURFACE OF UNPAVED PORTION OF TRAIL.
- II. INSTALL ADDITIONAL BENCHES OR PICNIC TABLES.
- III. INSTALL ACCENT TRAIL LIGHTING.
- IV. PERFORM GENERAL LANDSCAPE MAINTENANCE.
- V. ASSESS AND MONITOR PAVEMENT CRACKING FOR POTENTIAL REPAIRS.

Cracks in the existing concrete alarmed evaluators, not because they pose an immediate threat to walkability, but due to long-term repair costs if the damage is not monitored and repaired appropriately. These should be assessed regularly, and repaired as necessary, to mitigate avoidable costs.

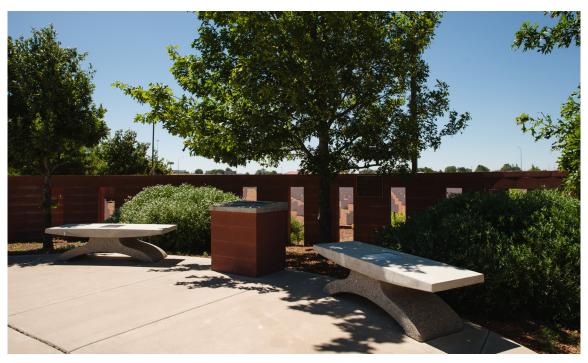
The existing trail features several art installations, as well as benches for resting. Trees and other vegetation provide filtered, natural shade depending on the time of day, however no dedicated, constructed sun shades exist for permanent shade. Bushes and other vegetation partially block access to the trail in several locations, easily remedied with a minimal amount of landscape maintenance.

The existing walkway features benches and shade trees.

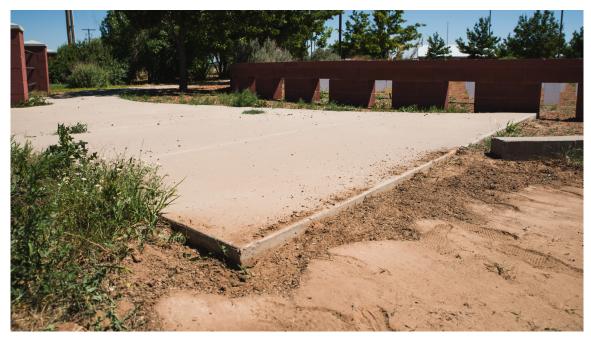
Transition zone between the existing pathway and planned expansion.

The unpaved portion of the trail is clearly delineated, functionally completing a walking path around the perimeter of the memorial. However, its surface is currently an amalgamation of materials and in need of improvement. A variety of walking surfaces will work well here, including something as refined as finished concrete, or more economical, such as compacted natural materials. Regardless of materials chosen, the transition between the existing and new walkways should be considered a developmental priority, merging the two surfaces in a smooth fashion to avoid trip hazards.

This is great news for the memorial and follows suit with its community engagement roots. As noted, the transition between pavement and crusher fines will require an appropriate design such that a smooth surface can be established, and maintained, over time. Per representatives, the crusher fines path may not initially be ADA compliant, however a city engineer may be utilized to inspect the path after its completion for a more comprehensive assessment.
